Evaluation of rotor vibration in gearboxes

by Steven M. Schultheis, P.E.

Bently Nevada Corporation

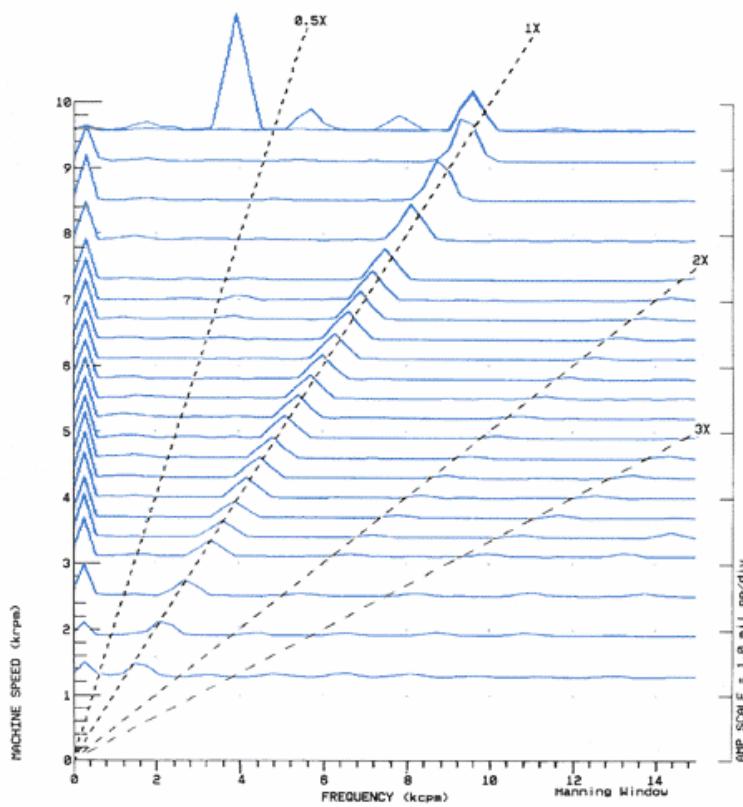
Figure 3. Spectrum cascade plot, pinion coupling-end startup data.

decrease. When this frequency equals the running speed, the fluid-induced instability occurs, and the pinion shaft vibrates at .43X (43% of running speed). One of the primary methods to correct a fluid-induced instability is to increase shaft eccentricity ratio to nearly 1. This is easily accomplished in a gearset by loading up the driven machine. Increasing the load increases both the gear separation force and the tangential force, moving the pinion to the top left quadrant of the bearing. As the pinion load increases, the eccentricity and bearing stiffness increase and λ decreases, and oil whirl stops. Figures 3 and 4 show spectrum cascade and orbit/timebase data from the pinion during a startup of a gearset in a wet gas compressor train where the pinion experiences an instability. The instability begins just below the 9567 rpm running speed of the machine.

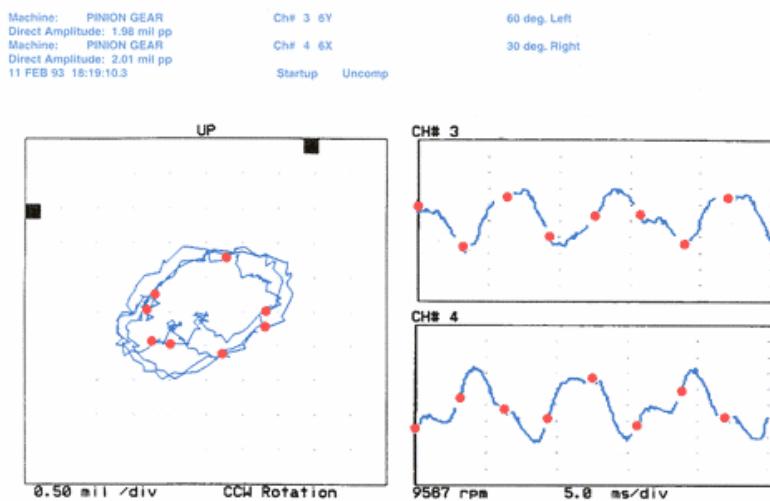
Figure 4. Orbit/timebase plot at the pinion coupling-end, no load on the compressor.

The shaft centerline plot (Figure 5) for this same startup shows that, due to alignment offsets, the pinion actually started in the top of the bearing. As the gearbox approached running speed, the average position of the pinion moved to near the center of the bearing. As a result, the pinion went unstable. The solution to this problem was to load the compressor. Loading the compressor increased the gear forces which acted to increase shaft eccentricity and stabilize the pinion.

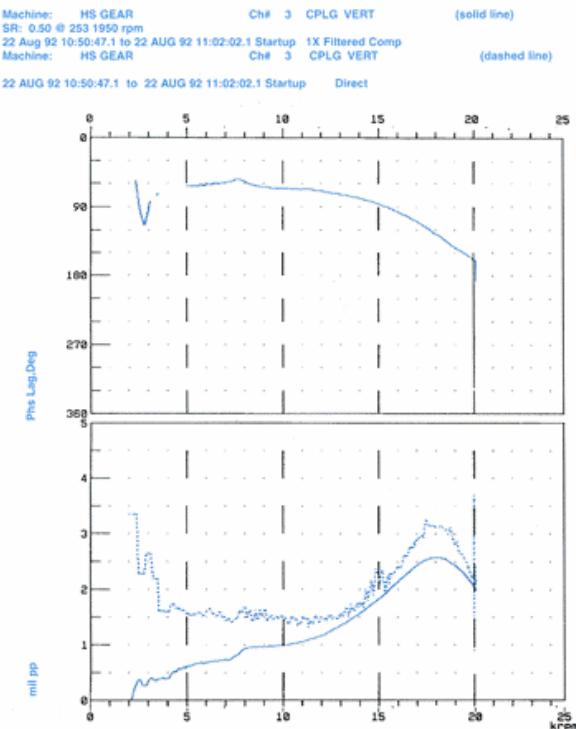
Figure 6. Bode plot of the coupling-end bearing vibration response. The pinion passes through resonance at approximately 19,000 rpm.

balance resonance. In general, a Bode plot for a gear element will show, with increasing speed, a constant phase lag angle and a gently increasing amplitude. The Bode plot in Figure 6 shows the 1X response for a high speed pinion in a gearset with an input speed of 3600 rpm and an output of 19,865 rpm. The Bode plot indicates that the pinion is running just slightly above a balance resonance. From the frequency of the amplitude peak and 90° phase shift, we would conclude that the resonance is at approximately 19,000 rpm. This is unusual and, based on the vibration level of 64 to 76 $\mu\text{m pp}$ (2.5 to 3 mil pp), not at all satisfactory. The problem in this case was due to a very long shaft extension on the pinion, and a very heavy coupling, which lowered the resonance frequency of the pinion. The problem was solved by shortening the pinion shaft extension and using a reduced-moment coupling, although it involved resetting the spacing between the machine cases. The vibration characteristics upon restart were quite satisfactory.

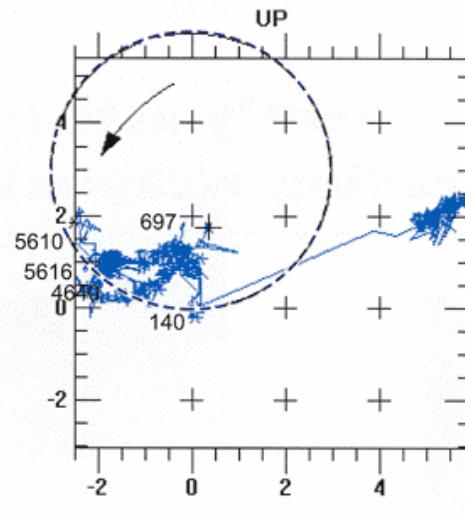
Figure 7. Shaft centerline plot for the coupling end of the pinion.

the bearing. Gap voltage data, acquired as the unit cooled down overnight, showed that the pinion moved up approximately 25 μm (1 mil), and to the right 102 μm (4 mil). This is most likely due to the alignment offset between the gear and the driven machine, and may indicate greater clearance than was expected.

A complicating factor would exist if the maintenance crew had used a thick sealant, such as silicone RTV, to seal the splitline of the gearbox during the turnaround. Since the bearings are retained by the gearbox cover, if the splitline is held open with the sealant, then the bearings can move relative to the case. Since the proximity probes are typically mounted to the gearbox lid, both the shaft and the bearing can now move relative to the proximity probes. This type of condition could also explain the excessive shaft centerline movement. In general do not use an RTV sealant compound that would affect a controlled dimension for sealing machine components, for example, radial or thrust bearing housings.
